Manhole Inspection Summary

Manhole # S29II_017MH

Insp Date: **4/10/07 9:37 AM**

Location Address: **1734 BOLTON ST**

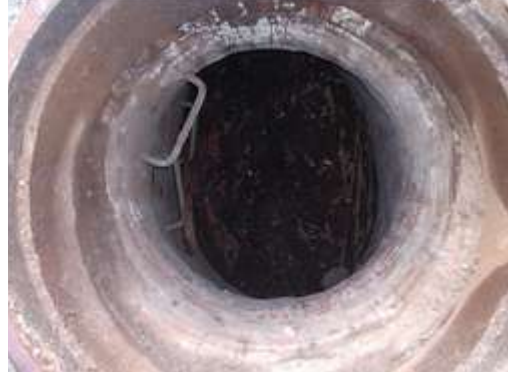
Top View

Corroded steps. Channel debris.

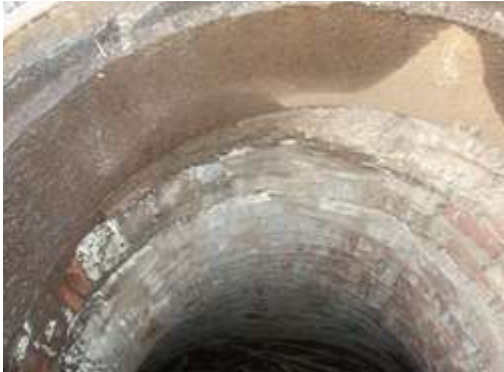
Defect

Frame leaks. Frame offset. Adjustment deterioration and infiltration. Corbel infiltration - other side.

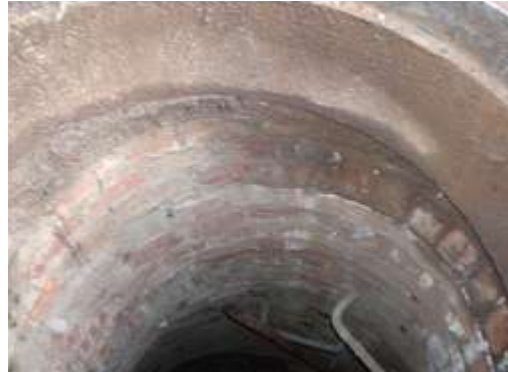
Defect

Frame leaks. Frame offset. Adjustment and Corbel infiltration.

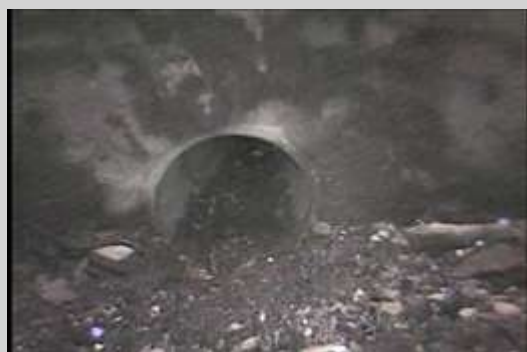
Pipe Out @ 12 O'Clock

Barrel infiltration.
